Progress Report

SITE NAME: South Tacoma Field (STF), Tacoma, Washington

PREPARED BY: Kennedy Jenks

DATE: 7 March 2022 for Reporting Year 2021

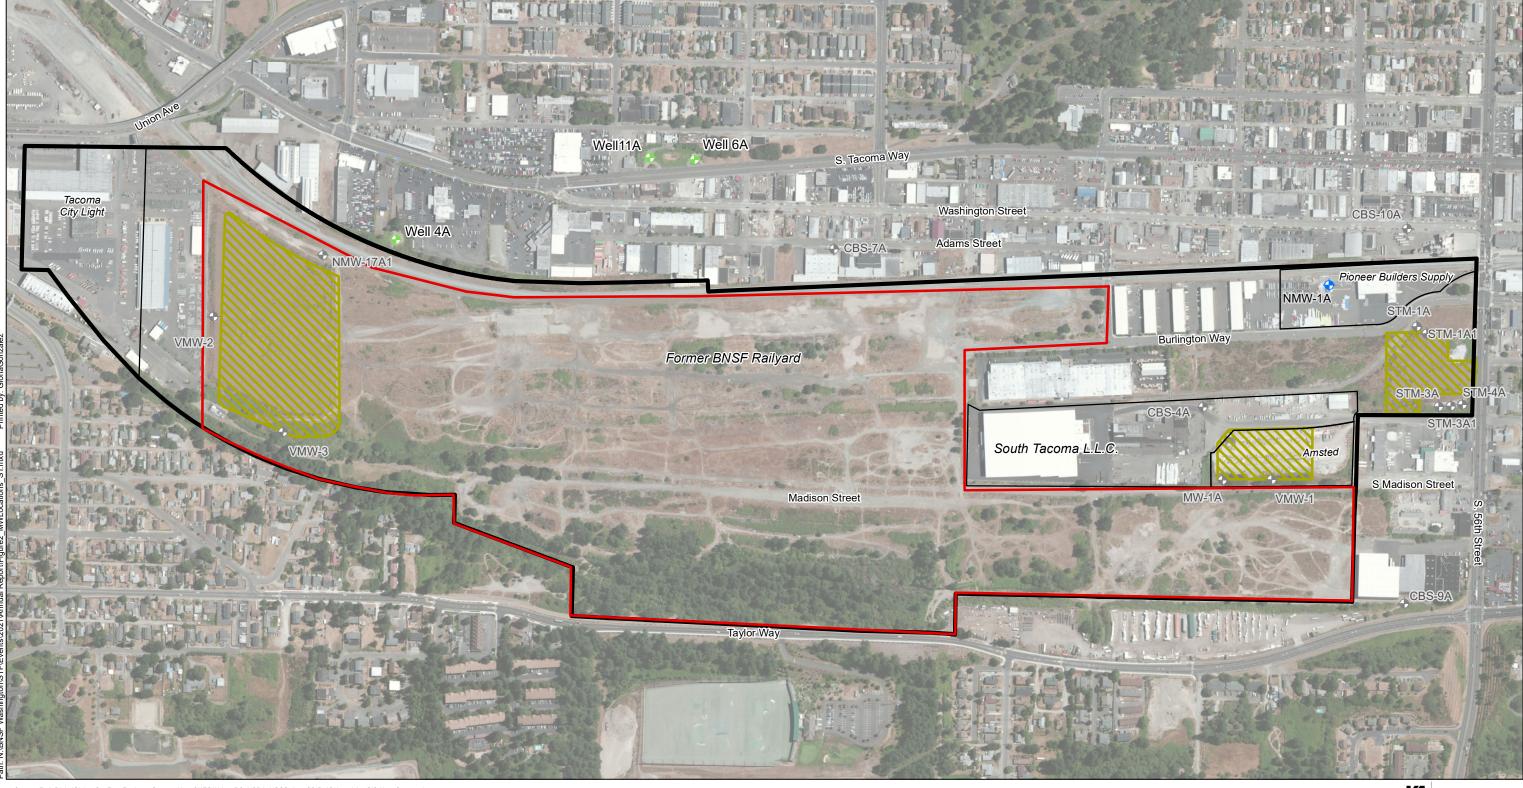
Figure 1

- All locations are approximate.
 STF = South Tacoma Field, OU = Operable Unit.
 A portion of the Facility, as shown above, was sold to BRIDGE in 2021.

Site Map and Monitoring Well Locations

Actions completed at the South Tacoma Field (STF) (Site) in 2021 included submittal of two groundwater attainment analyses of site groundwater cleanup levels (CULs), decommissioning four wells (NWM-17A1, NMW-10A, STM-1A1, and STM-3A1), annual groundwater monitoring of well NMW-1A, and a cap inspection. Well locations are shown on Figures 1 and 2.

A portion of the Site was sold to Bridge Development Partners, LLC (BRIDGE) in 2021, as shown on Figure 1, and includes the BNR Dismantling Yard and grids 452, 453, 460, 461, 493, 494, 500, 501, 520, 532, 533, 538, 550, 554, 586, 703, 767, 785, and 879. Per the sale agreement, BRIDGE is responsible for conducting inspections, performing maintenance, and annual reporting for their portion of the Facility.

In December 2019, EPA approved of BNSF and Amsted decreasing cap inspections to a rolling 18-month cycle. A cap inspection was conducted in December 2021 and excluded the portion of the Site sold to Bridge, as shown on Figure 1. During the cap inspection,

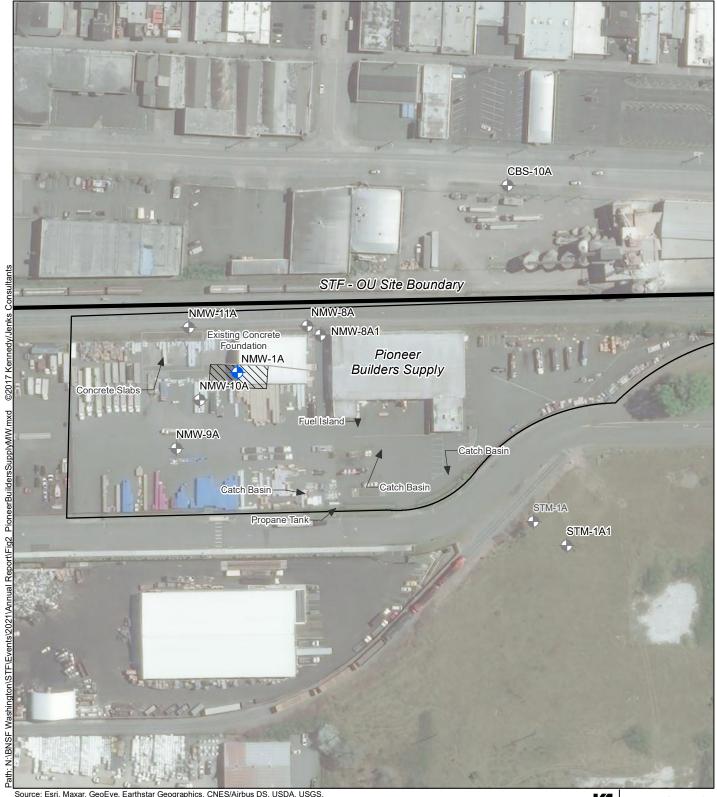
Figure 2

Pioneer Builder Supply Monitoring Well Locations
